Use of Guided Long Wave
Ultrasonic Inspection for Anomaly
Locating and Use of Composite
Repair Materials

12" x 10" M-2 Oil Pipeline

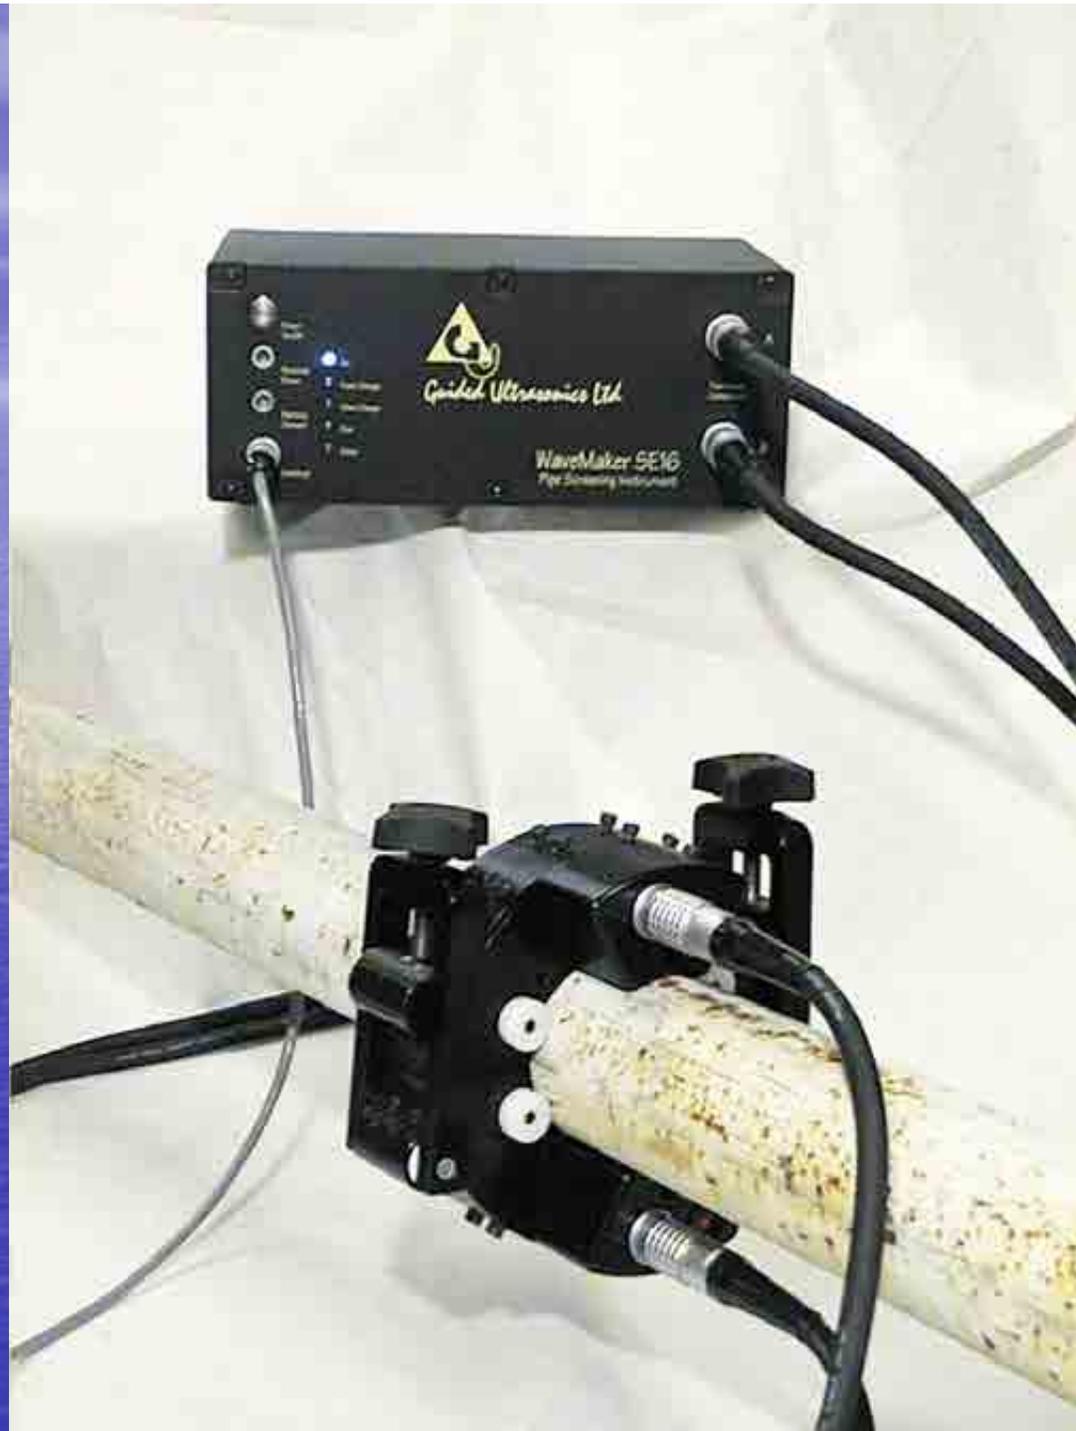
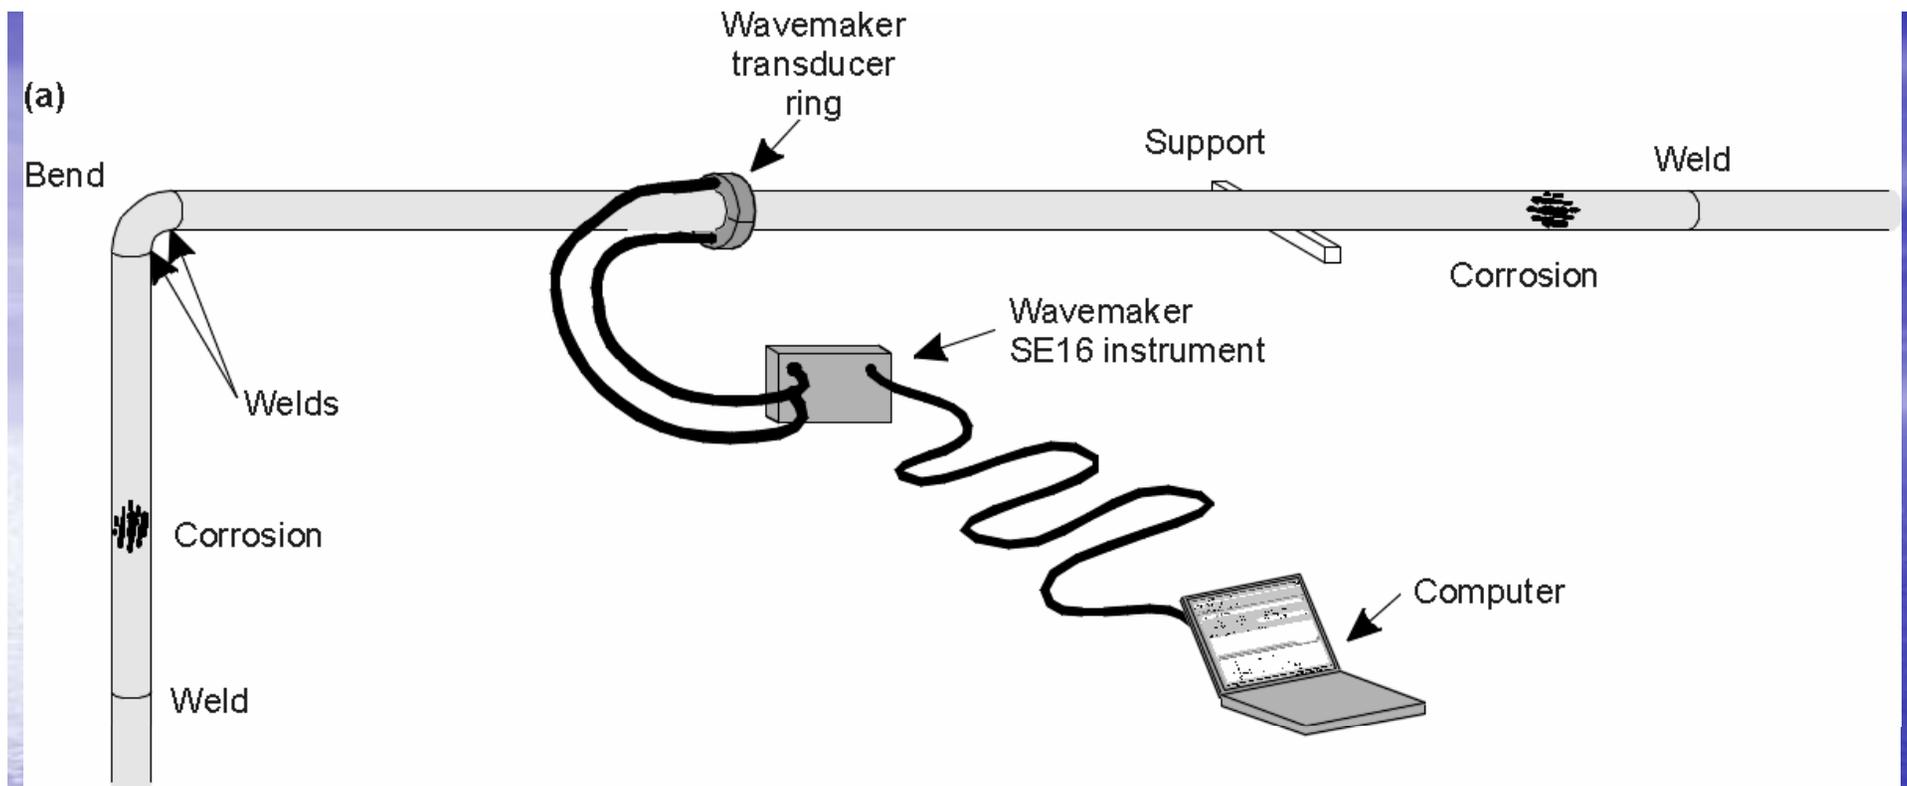
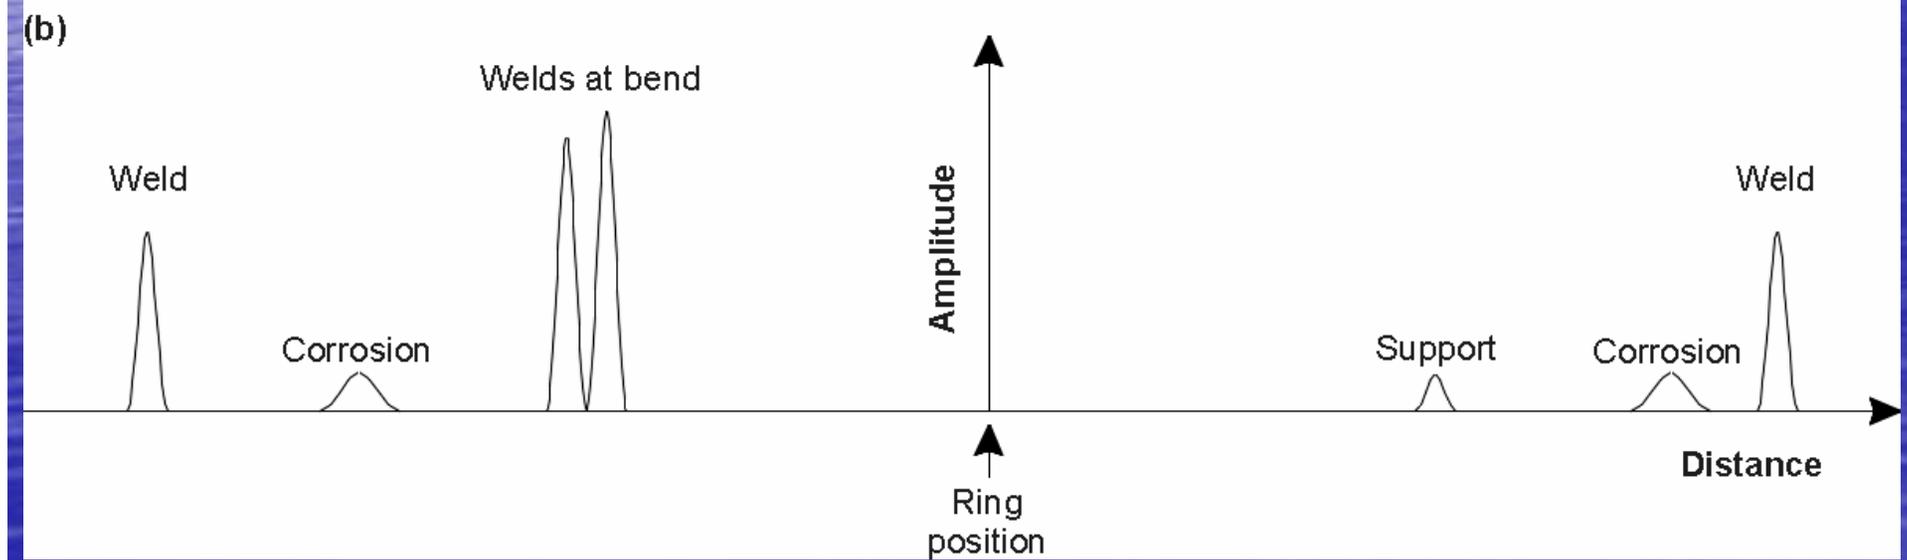
- Guided Wave Ultrasonic Inspection
June 4, 2004
 - “Shoots” ultrasonic signal down pipe and looks at reflections

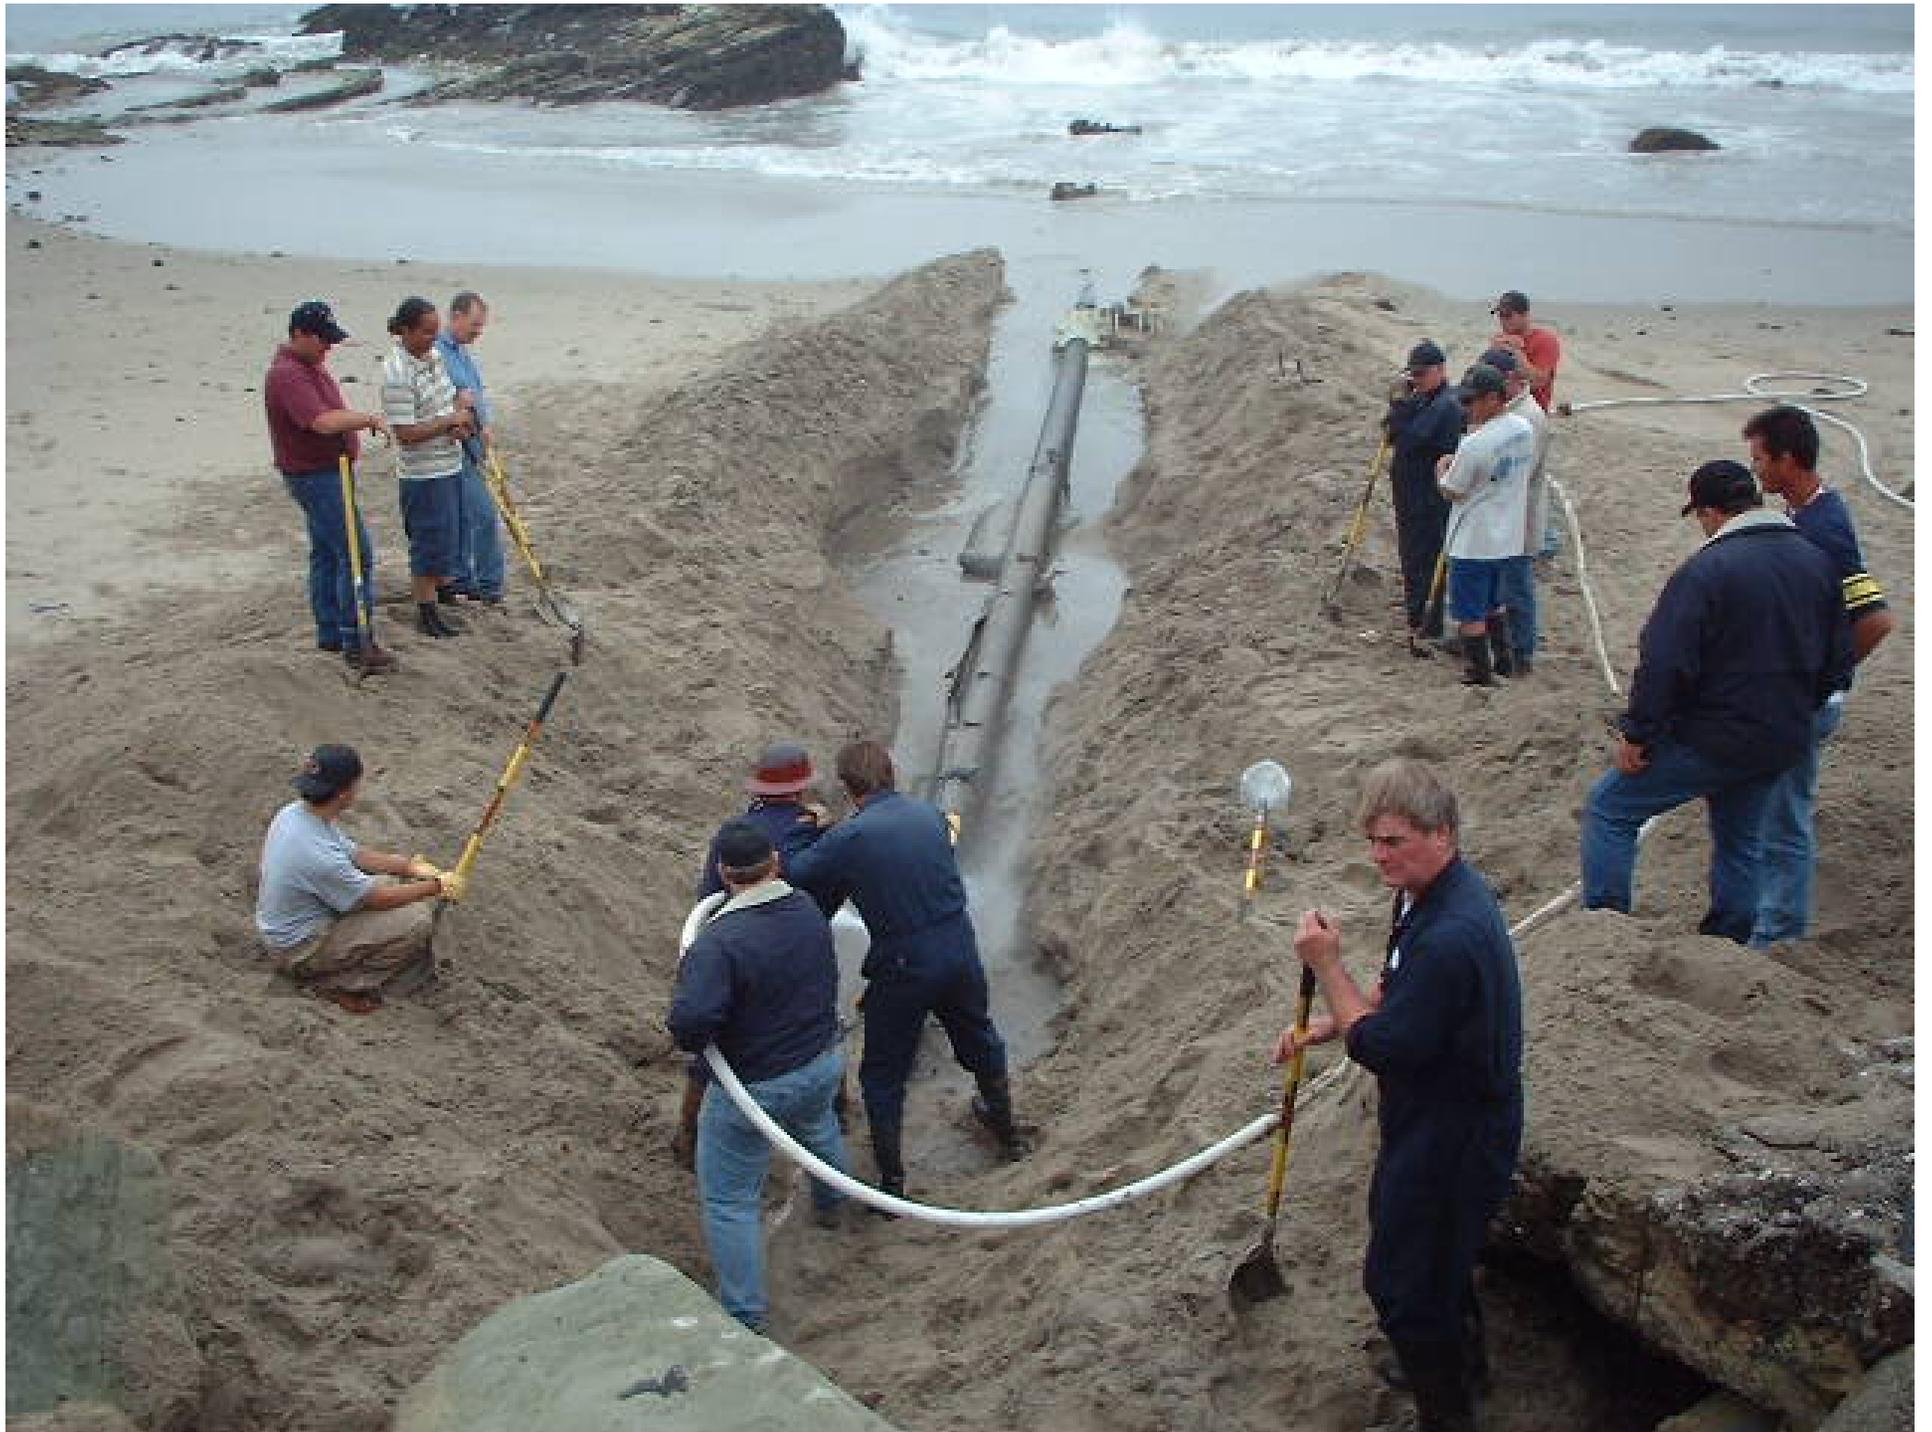
- Guided Wave Ultrasonic Inspection –
June 21, 2004
 - Re-excavated beach based upon
correlated findings

- Located two anomalies – external scouring of pipe

- Guided Wave Ultrasonic Inspection – June 21, 2004
 - Found 0.155" WT (58.6% loss) and 0.204" WT (45.6% loss)
 - Defects located within 45" of each other
 - About 12' total pipe exposed to scour
 - Subjected to RSTRENG analysis, determined true MAOP was 1188 psi, well above 740 psi
